**Maryland Historical Trust  
State Historic Sites Inventory Form**

Survey No. HA-1968

historic Gahagan House

street & number 1027 Main Street

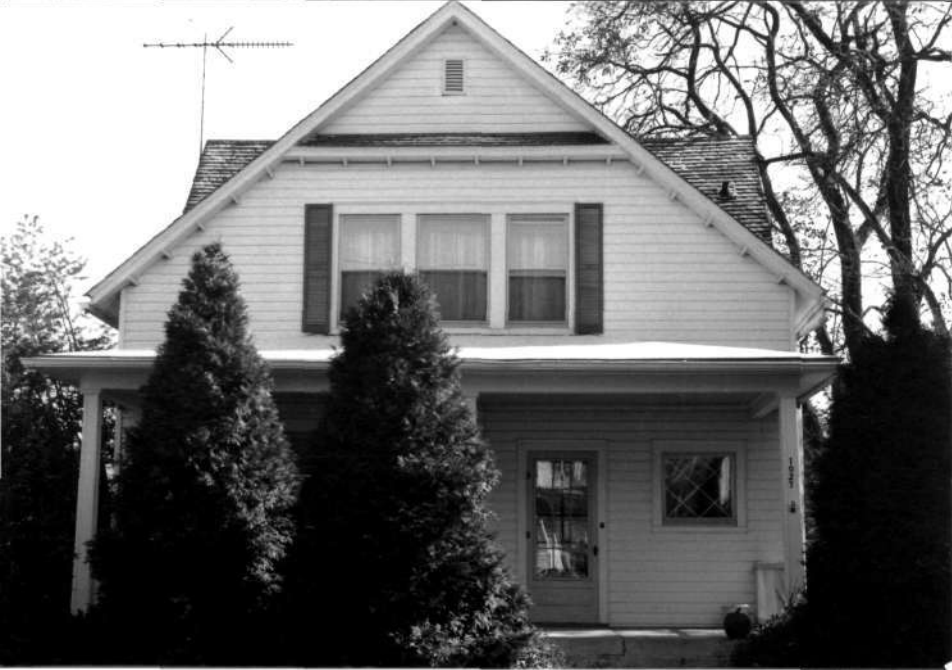
15A-1968 WEST ZAKADE

The front or west facade is three bays wide on the first floor, with a centrally located triple window in the gable on second floor. There is a single story porch with a hip roof across the length of this facade. The most prominent feature on this facade is a triple windowed bay projection to the left of the asymeterically placed eight paned French door. The top quarter of the center window of the bay has a cross-hatched pattern. This pattern is also noted on a smaller square non-opening window to the right of the entrance. The eaves on this facade, as well as the north and south gable ends have small brackets. Also noted is a vent roof type feature across the top half of the gable on this facade and those on the north and south ends. These decorative features are found on the Arts and Crafts style houses.

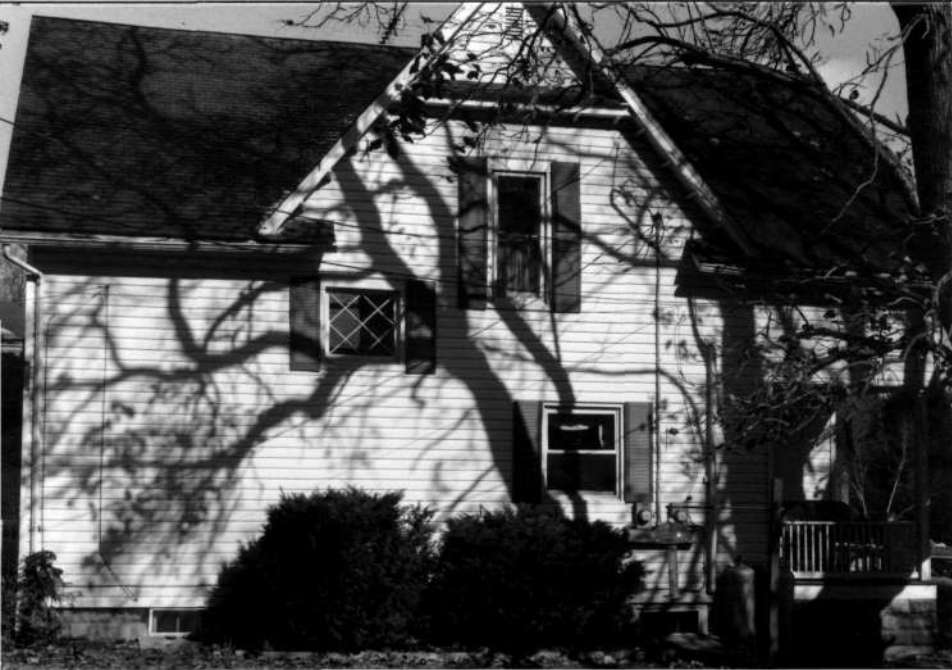
HA-1968  
SOUTH FACADE

The south facade features three asymmetrical fenestrations. On the first floor a 1/1 window is located approximately two thirds of the distance from the west facade. There is a small square non-opening window with a cross-hatched pattern located near the top of the first story. This corresponds with a stairway landing. On the second story there is a single 1/1 narrow window centrally located in the gable end.

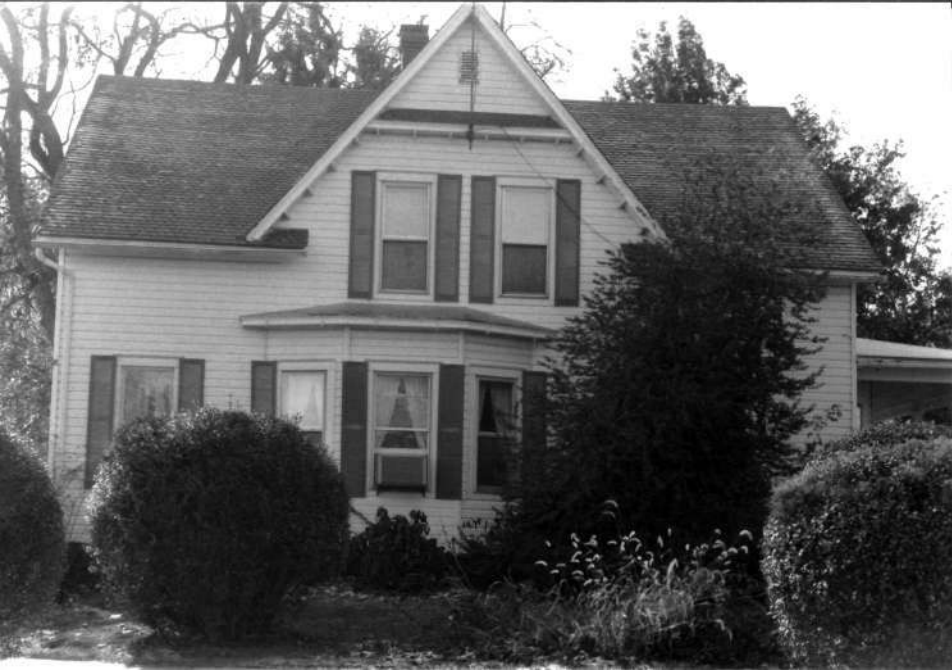
HA-1968  
NORTH FACADE

The north facade is fenestrated with five windows similar to others in this house. Three of these are in a hip-roofed bay approximately midpoint on first floor facade. The second floor has two similar windows in the gable.

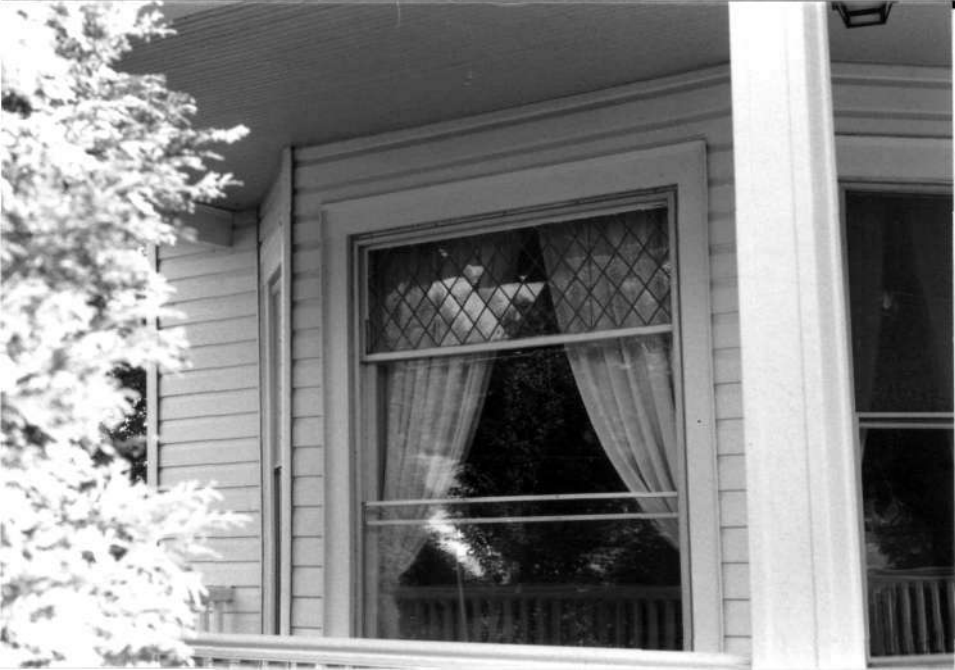
HA-1968  
WINDOW DETAIL  
OF

WEST FACADE BAY

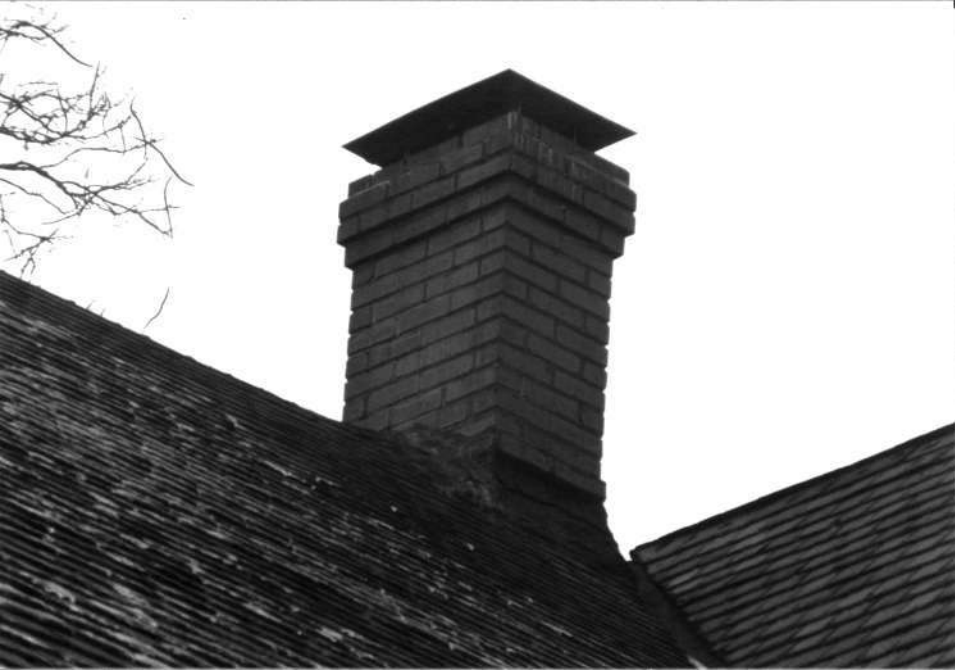
HA-1968  
CHIMNEY DETAIL

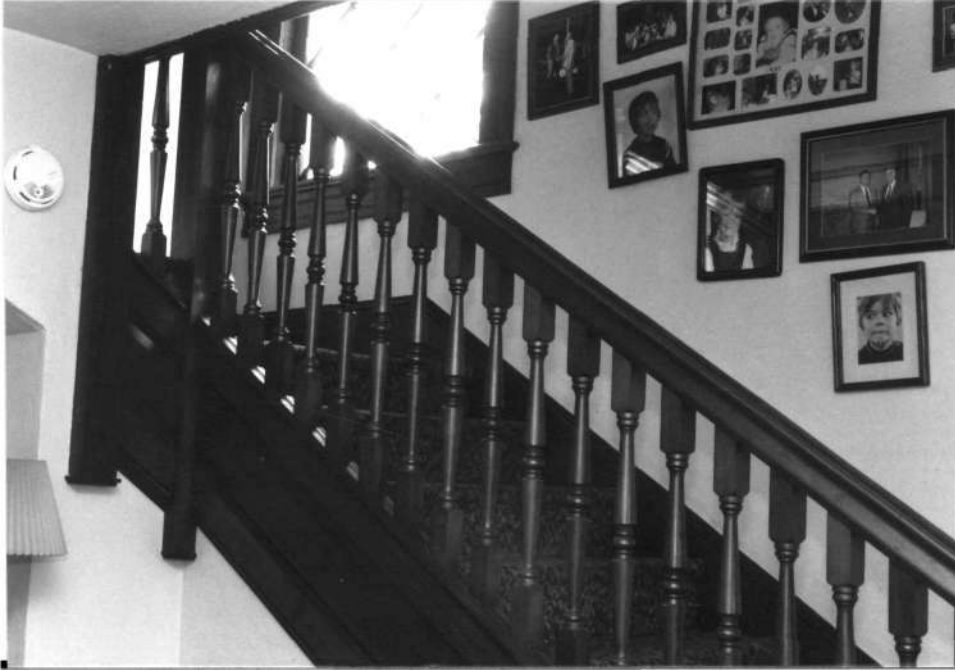
HA-1968  
STAIRWAY DETAIL

The interior floor plan is a side hall with double parlor. The main entrance is from the west facade. The stairs rise in the entry along the west wall to a landing, then along the south wall to second landing and then northward to the upstairs central hall. The staircase is open with closed stringers and turned ballisters. There is a cross-hatched patterned window at each landing.

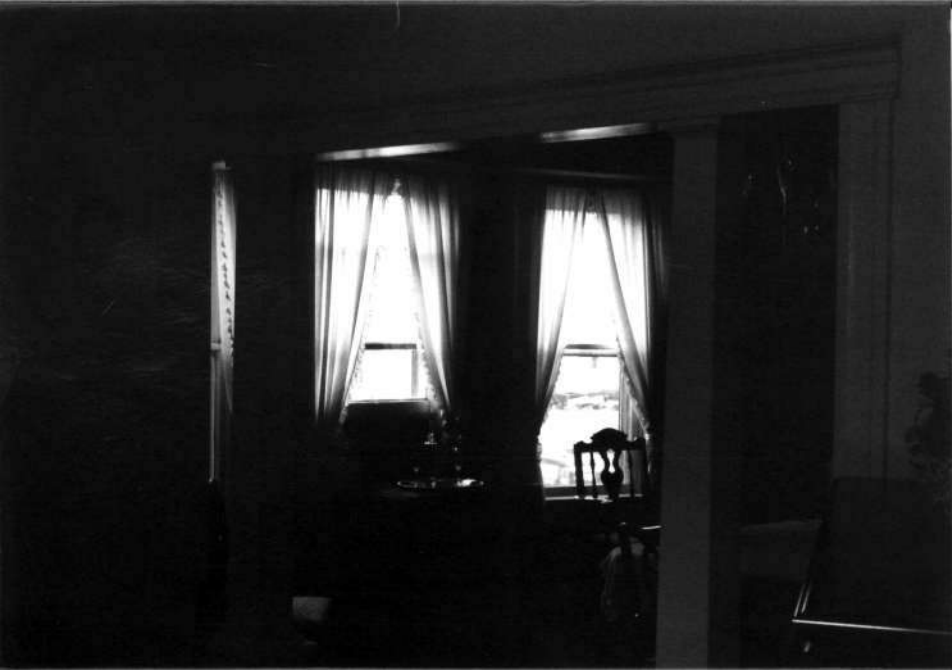
HA-1968  
ARCHWAY - DE:LR  
1027 MAIN ST  
DARLINGTON, MD

The pantry is located to the rear of kitchen and dining room. The dining room is located to the north of the kitchen and features a triple window bay on the north side with a door to the kitchen and to a small den next to the pantry. The west side of the dining room has a wide archway with two square columns. This archway separates the dining room and living room. The living room also features a triple bay on the west wall along with a single 1/1 window on the north wall. All floors a narrow tongue and groove oak, with the exception of tile in kitchen and pantry. Door and window surrounds are plain and are original to the house.

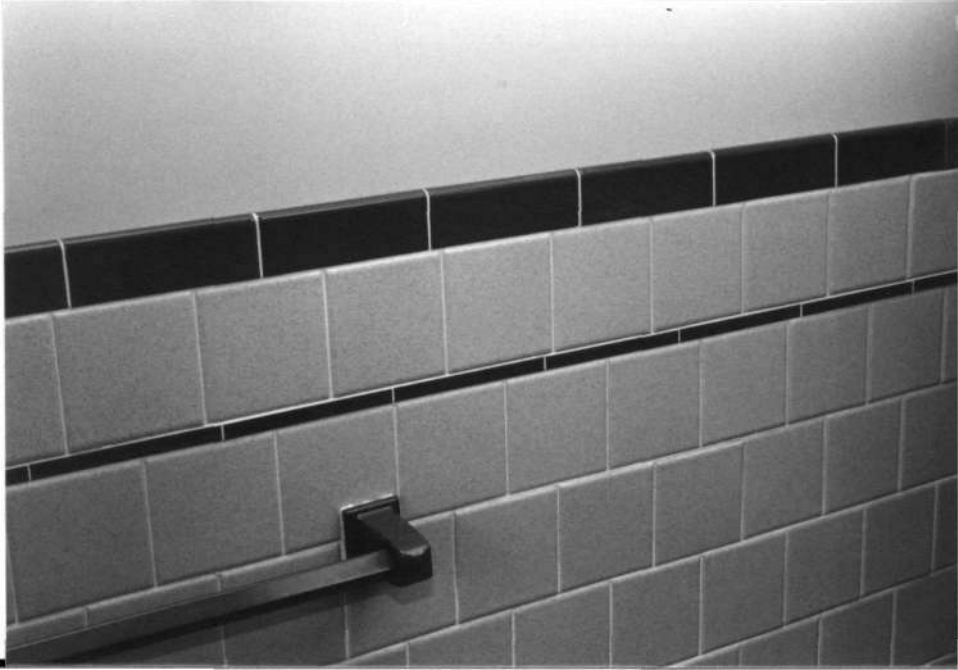
HA-1968  
ORIGINAL TILE - BATH

There is a central hall on the second floor running east and west with a trapdoor access to an attic which is unfinished. Radiating off from the hall are three bedrooms and a bath. The bedrooms are located in the west, east and north gabled ends. They are all approximately the same size with closets being located under the eaves. The bath room is located in the south side gable end and contains the original ceramic tile. The fixtures are not original.

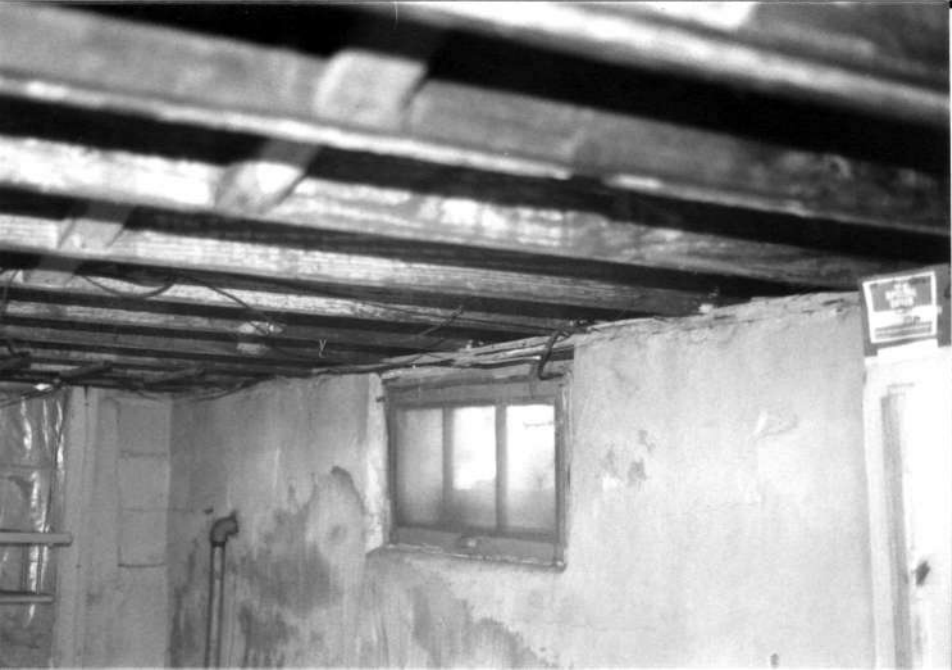
HA-1968  
CELLAR DETAIL

The cellar is the full size of the exterior dimensions of the house. It is plastered, but shows no evidence of being used for anything other than a cellar. It can be accessed by both an exterior stairway on the east and stairs from the kitchen.

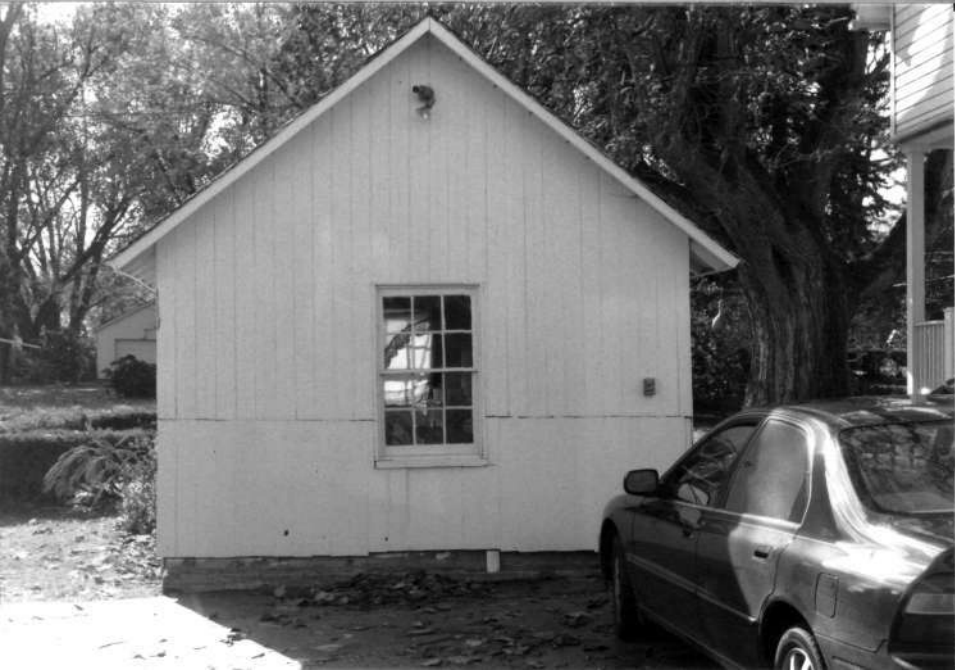
HA-1968  
RMP/SPRING HOUSE

There is a wood sheathed pump/spring house to the rear of the main house. It has a slate roof which is felt to be original. The interior is spartan with a concrete floor. There is also a two car garage with an attached apartment. These are of framework construction with asbestos siding and were not further surveyed.

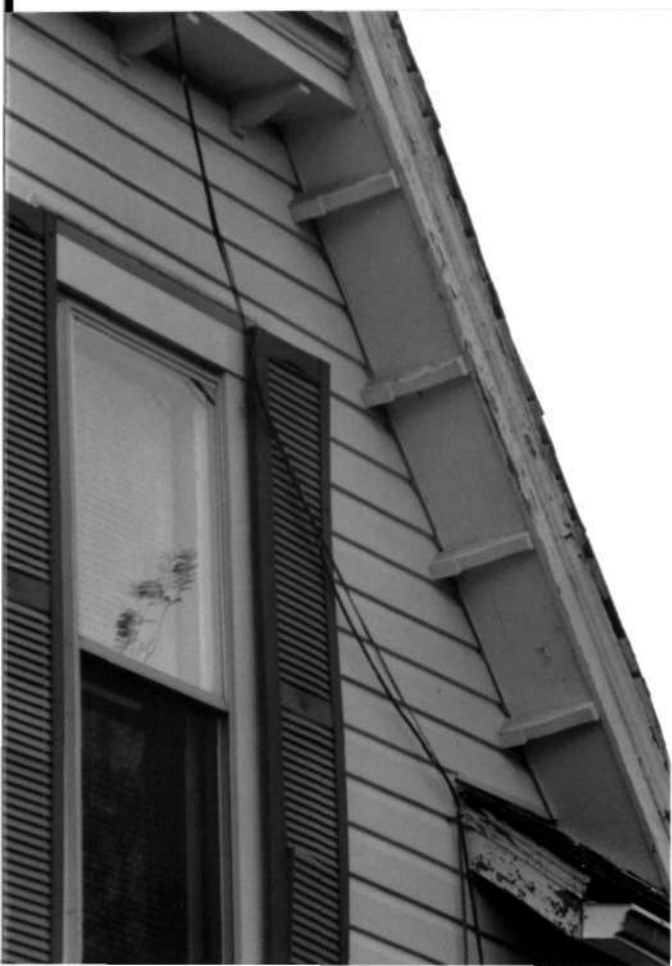
EAVE DETAIL: BRACKETS

The Gahagan House is a fine example of first half Twentieth Century vernacular housing. It features some Arts and Crafts details, i.e. cross-hatched pattern windows, pent roofs and small decorative brackets in the gable ends.

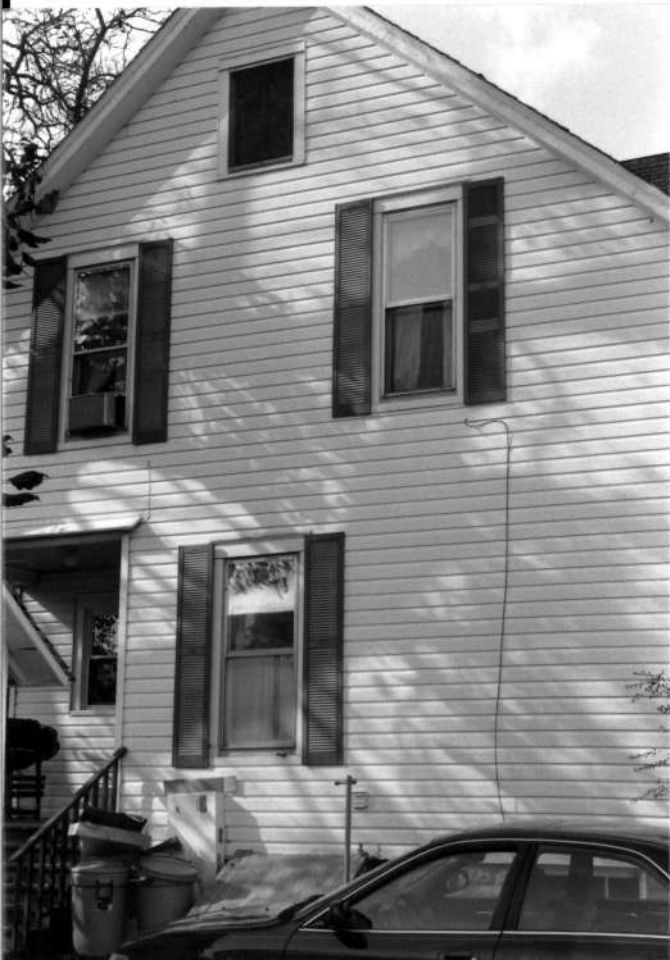
EAST FACADE - HA-1968

The rear or east facade features a covered porch with entry door and a 1/1 window. There is also a single similar window centrally located on the first story, along with two similar symetrically spaced windows on the second. There is a casement type vent in the peak of this gable.

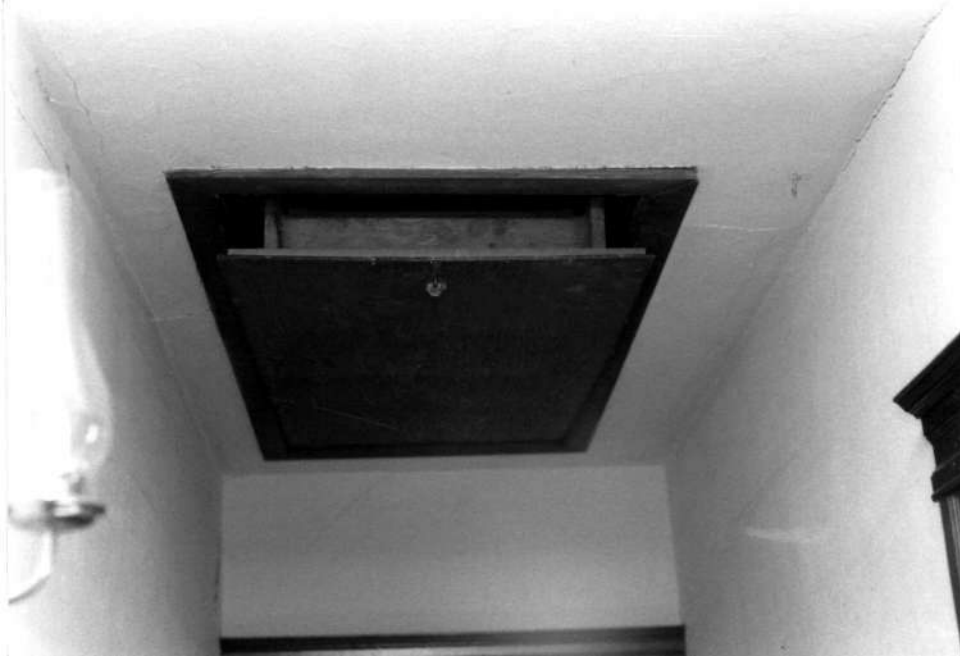
HA-1968  
ATTIC ACCESS
